# Common “paint” problems & Paint Guarantees

# Purpose of Common Paint problems & Paint Guarantee

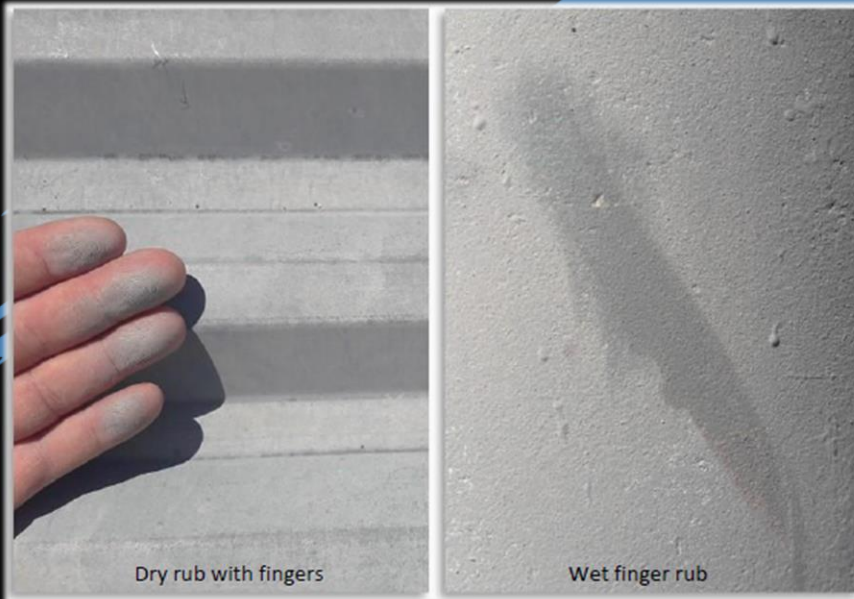
# Chalking

Occurs on all painted surfaces. UV light and general weathering breaks down the binders in paint surface over time to form a chalk like dust on surface. Often mistaken for fading

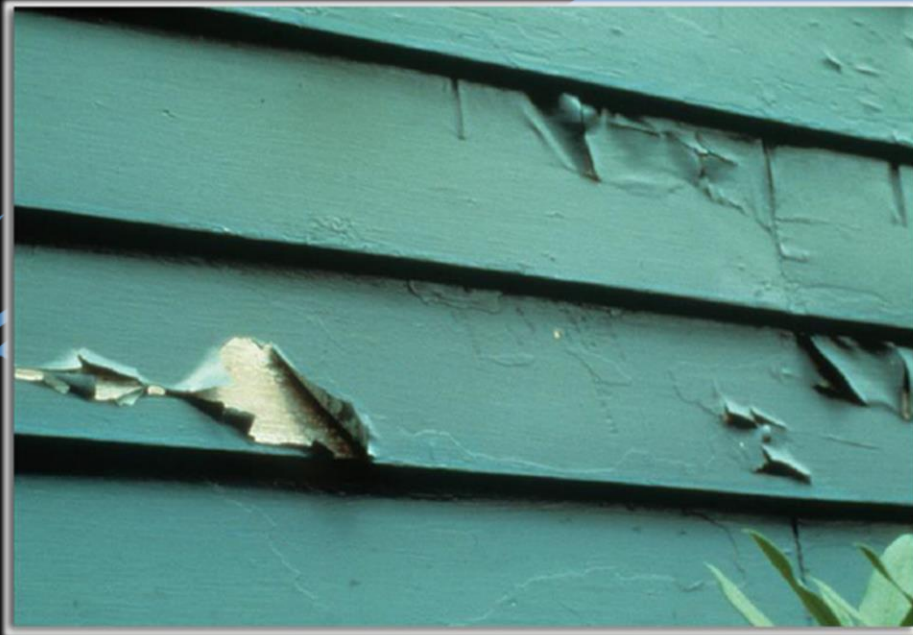
# Lifting & peeling

Often older original coatings in poor condition painted with new more flexible coatings. This creates surface tension and lifts the old coating from the surface. Dark colour will increase issues

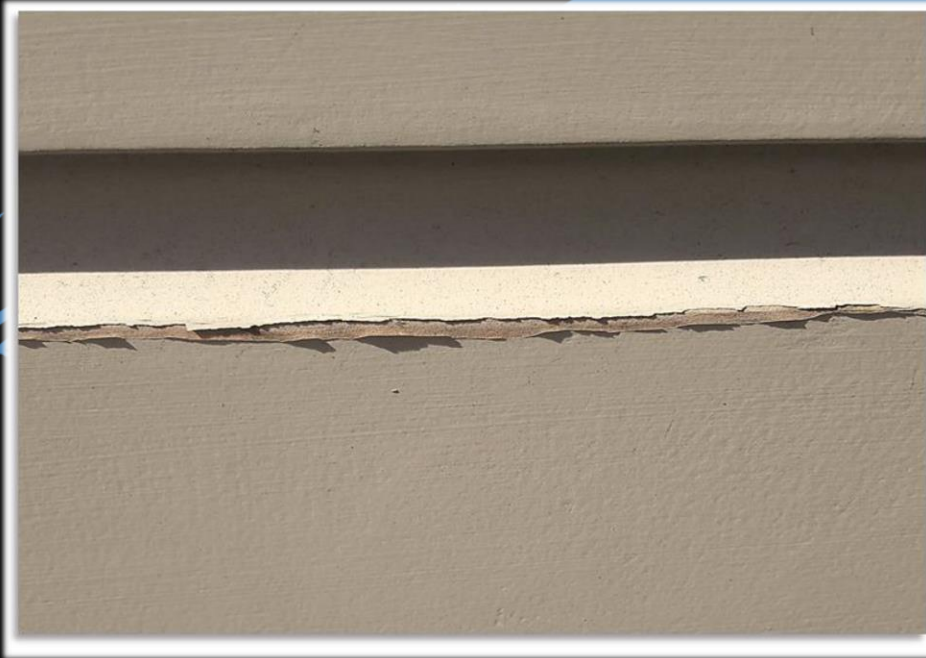
# Sharp edge splitting

Sharp edges cause stress in paint film, which pulls back from edge reducing film thickness. Thinner film area is affected by weather and moisture can migrate through. Timber can swell and split coating

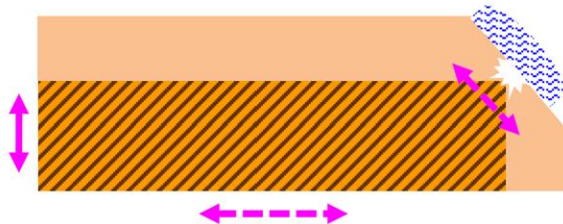
1. Paint pulls back from a sharp edge due to surface tension when in its wet stage.

2. Water sits on the edge, penetrates and swells the timber. The dry paint film is thinner and therefore cannot expand as much as a normal film and splits further.

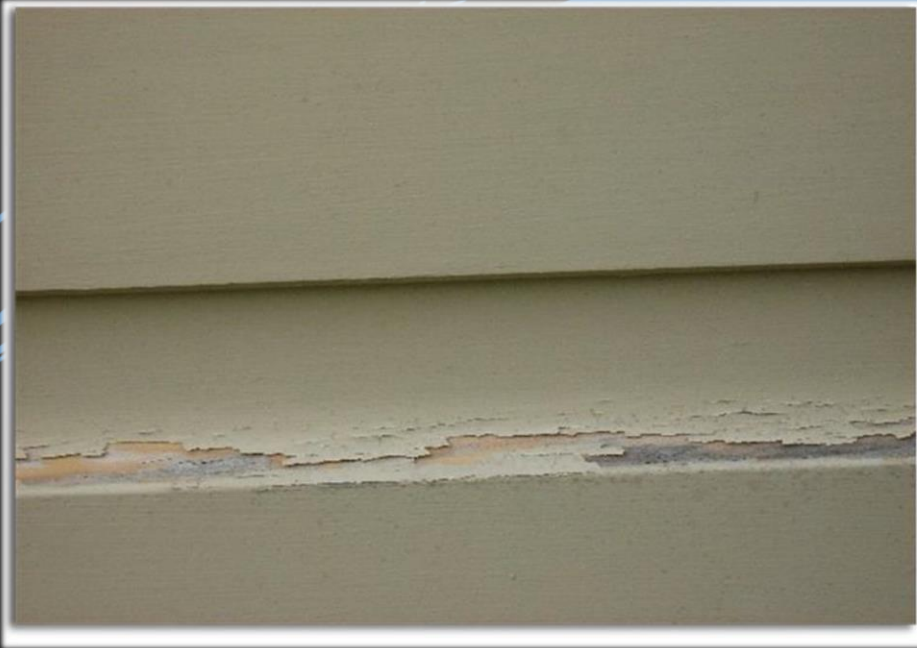
# Flaking & peeling

Increased exposure (double) to UV due to 30-45° angle. Sharp edge at base area starts the issue with low film build

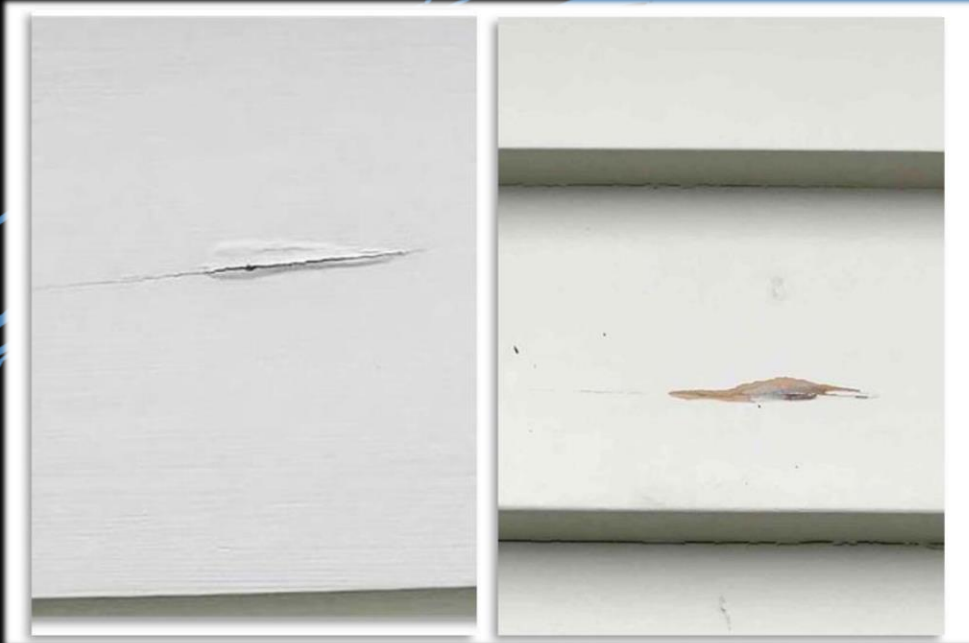
# Splitting - timber

Movement of timber along its grain boundary. Hairline crack occurs allowing moisture ingress with loss of adhesion occurring around area

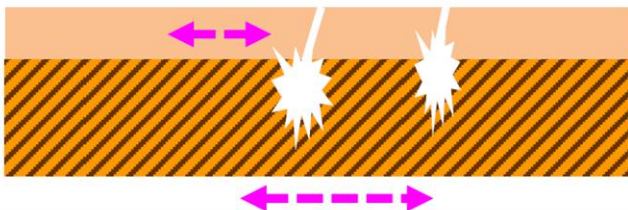
1. Stress is placed within the substrate grain structure which then moves beyond its cohesive capacity and splits along the grain. The paint film, which cannot move as much as the underlying substrate, then also splits at the weak point.

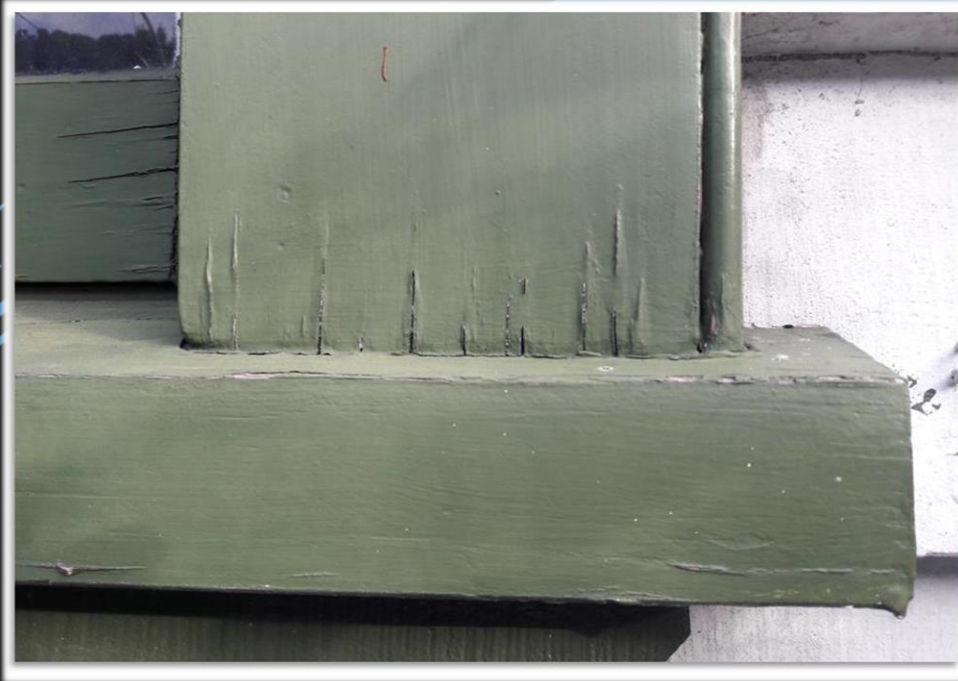
# End grain/cut splitting

Natural movement of timber causes cracks to open at joints creating a crevice. Moisture ingress occurs overtime causing splitting

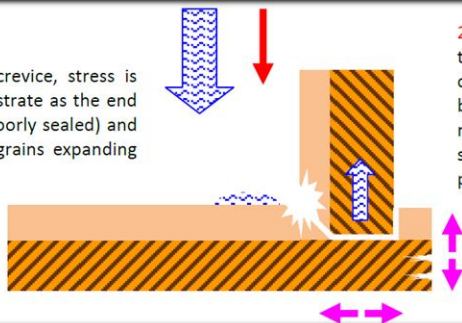
1. Water seeps into the crevice, stress is placed on / within the substrate as the end grains are not sealed (or poorly sealed) and the water travels up the grains expanding the timber.

2. The timber grain structure then moves beyond its cohesive capacity and splits at the grain boundary. The paint film cannot move as much as the underlying substrate also splits at the weak point.

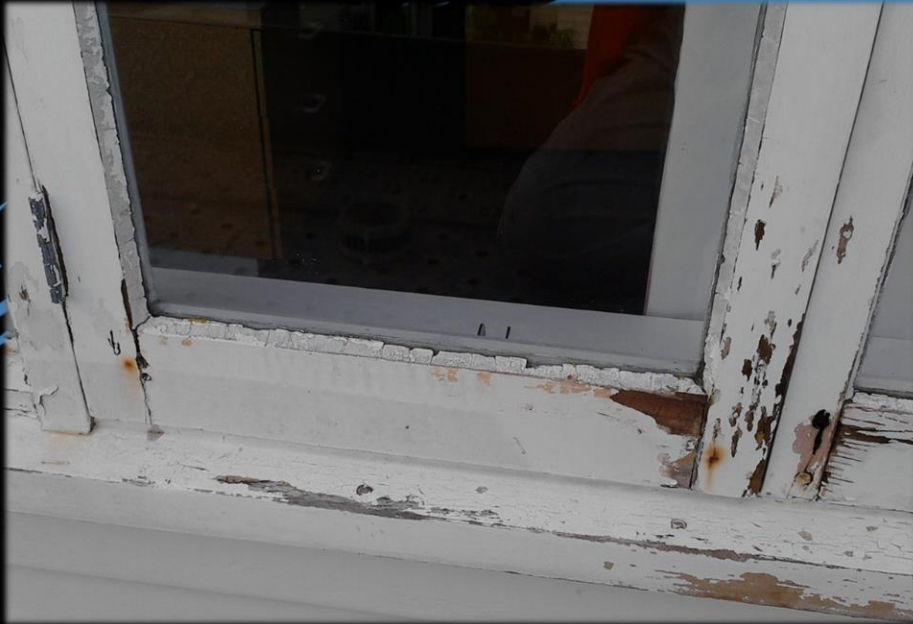
# Cracked Timber sashes & Sills

**Cause:**  
Natural movement of timber causes cracks to open at joints creating a crevice. Moisture ingress occurs overtime causing splitting

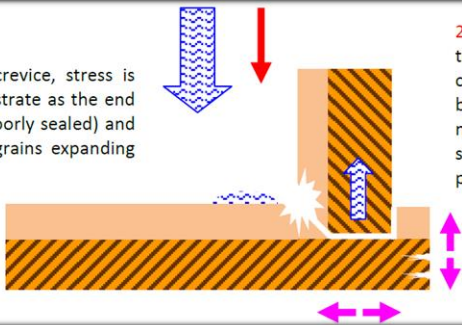
1. Water seeps into the crevice, stress is placed on / within the substrate as the end grains are not sealed (or poorly sealed) and the water travels up the grains expanding the timber.

2. The timber grain structure then moves beyond its cohesive capacity and splits at the grain boundary. The paint film cannot move as much as the underlying substrate also splits at the weak point.

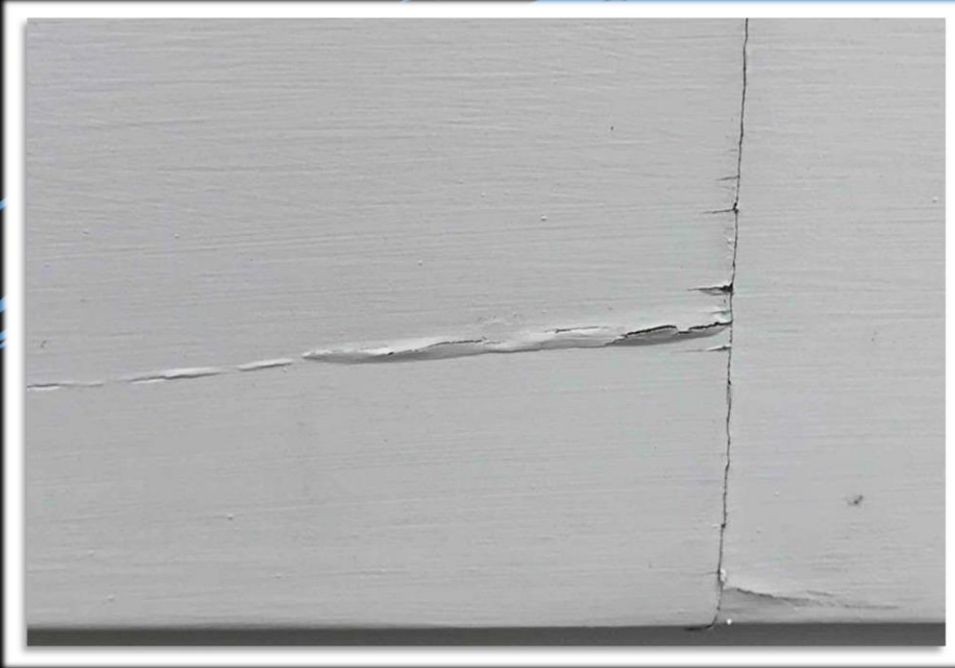
# End Grain Butt joint Splitting

Natural movement of timber causes cracks to open at joints creating a crevice. Moisture ingress occurs overtime causing splitting

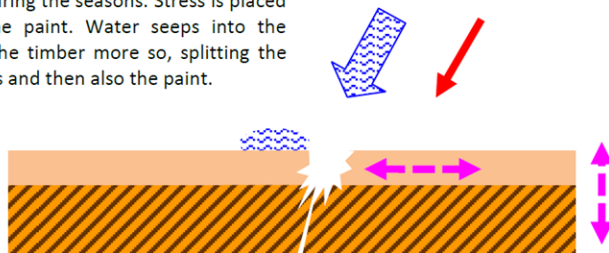
1. Timber naturally moves during the seasons. Stress is placed on the joint and cracks the paint. Water seeps into the crevice, which then swells the timber more so, splitting the timber at its grain boundary's and then also the paint.

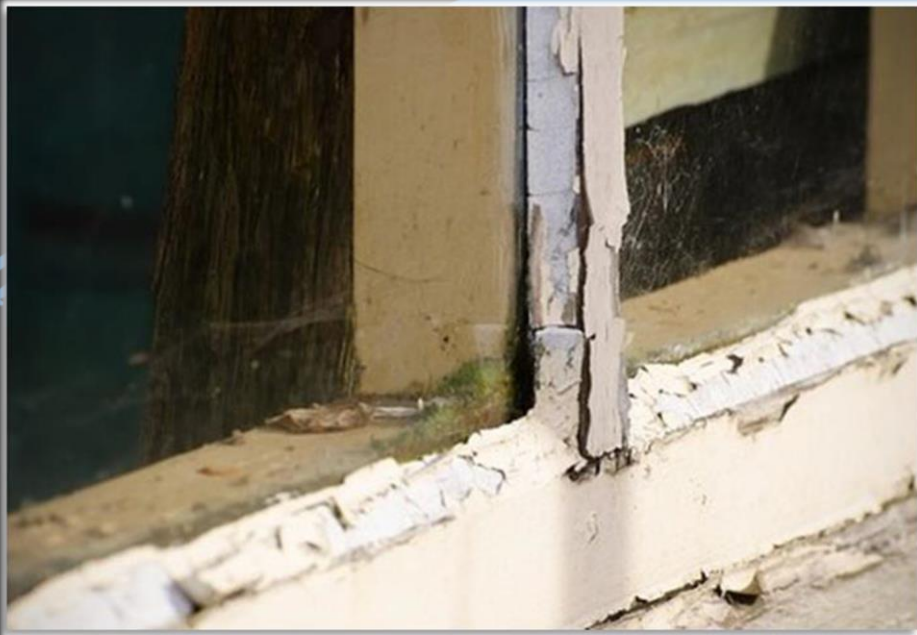
# Cracked Putty

Timber in rebates often not primed prior to putty. Long term weathering also allows moisture to creep in over time causing failure

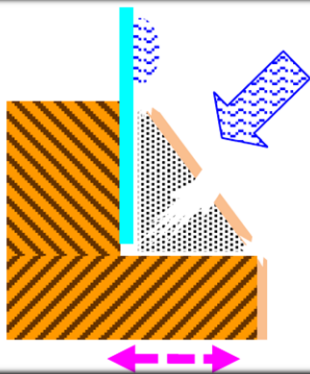
1. Water seeps into the crevice, cracks and between the glass/putty, which causes stress to be placed on and within the timber and paint film, splitting at any grain boundary weak point.

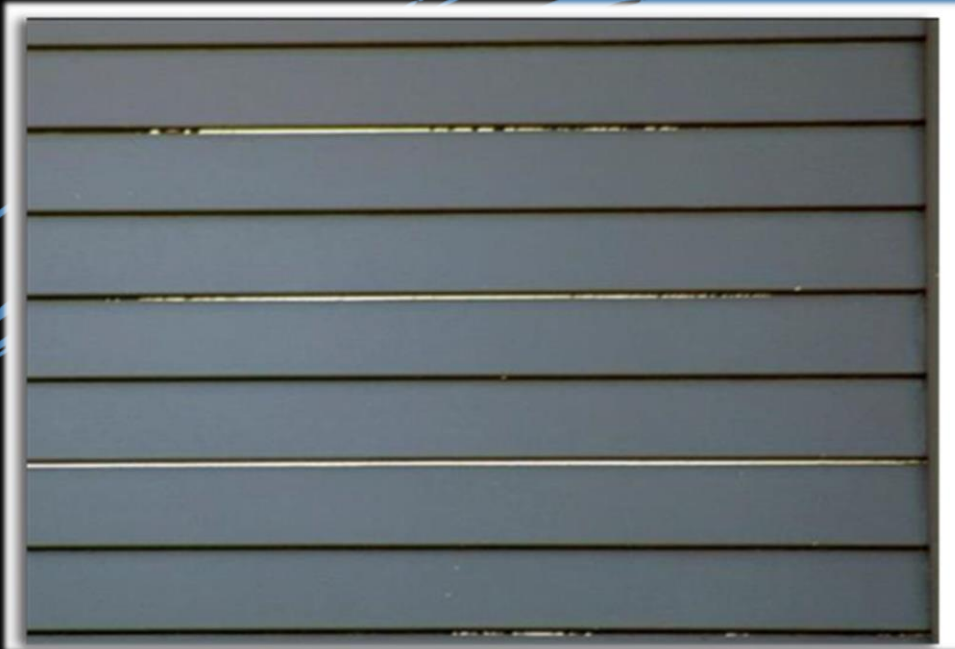
# Weatherboard Shrinkage

Timber expands and contracts through moisture uptake over the seasons causing movement in all weatherboards. Dark colours accentuates heat stress and movement.

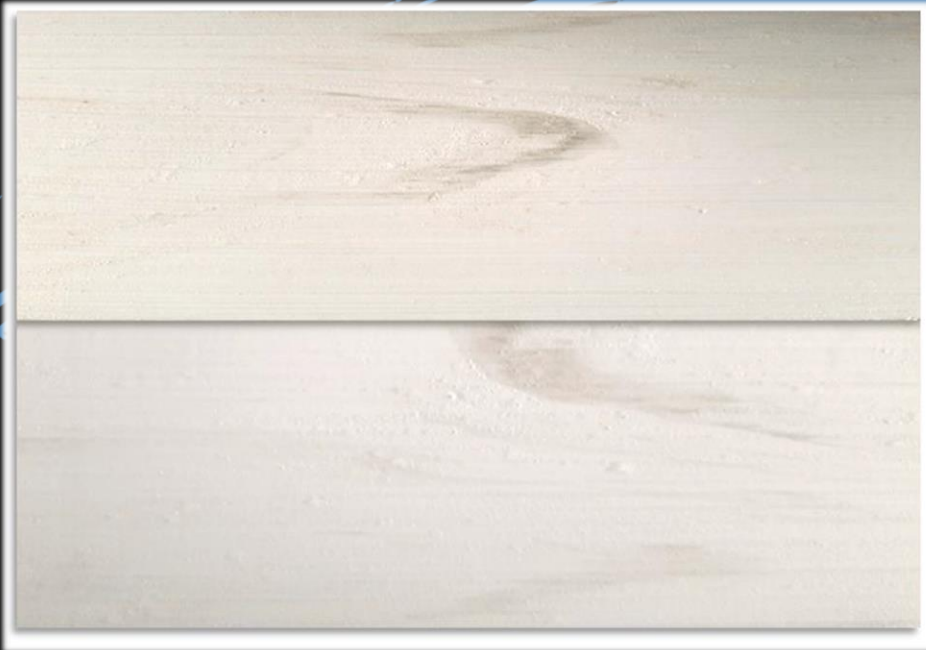
# Tannin Staining

Yellow/Red brown tannins migrate through paint or stain surface showing grain pattern (often occurs with cedar)

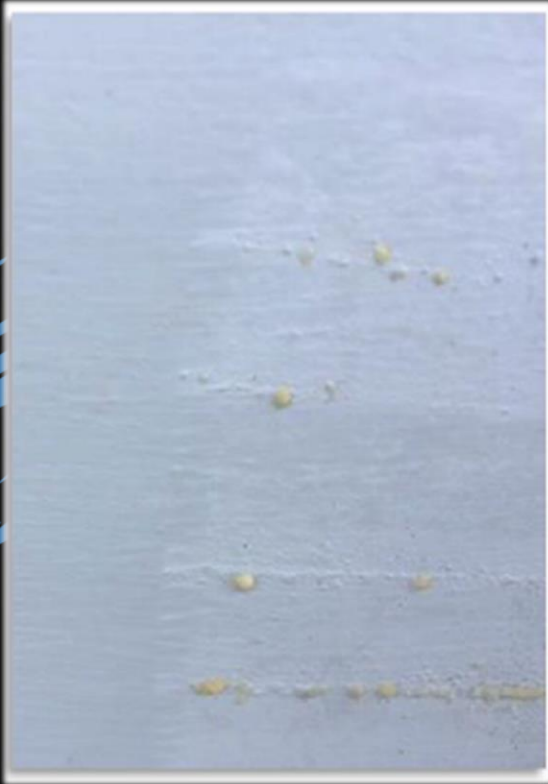
# Resin Bleed

Resinous (sappy) grain section of timber, when heated can migrate through coating. Darker colours exacerbate the issue. Often occurs with lesser quality timber

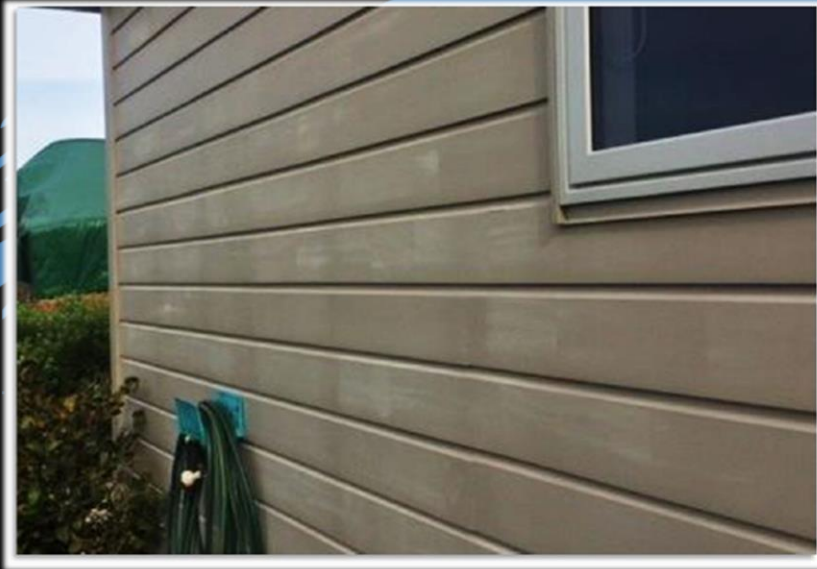
# Resin “show through”

Wood extractives migrate through a section of timber. Darker colours exacerbate the issue. Often occurs with lesser quality finger jointed pine in the smaller sections

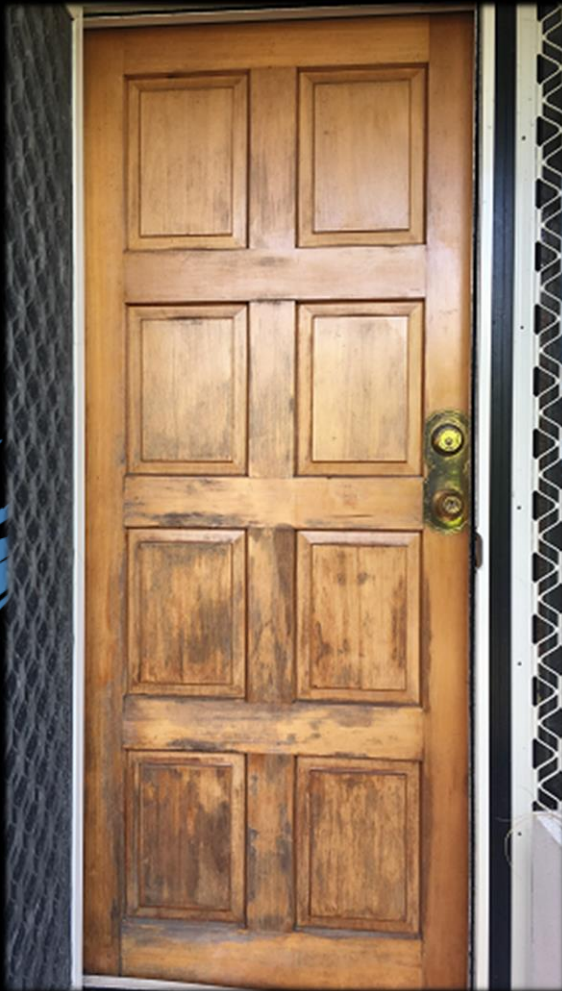
# Clear Coatings Exterior

UV light penetrates through Clear coatings and breaks down the timber cell structure. Splitting of coating and swelling occurs allowing moisture to penetrate. Premature coating failure always occurs

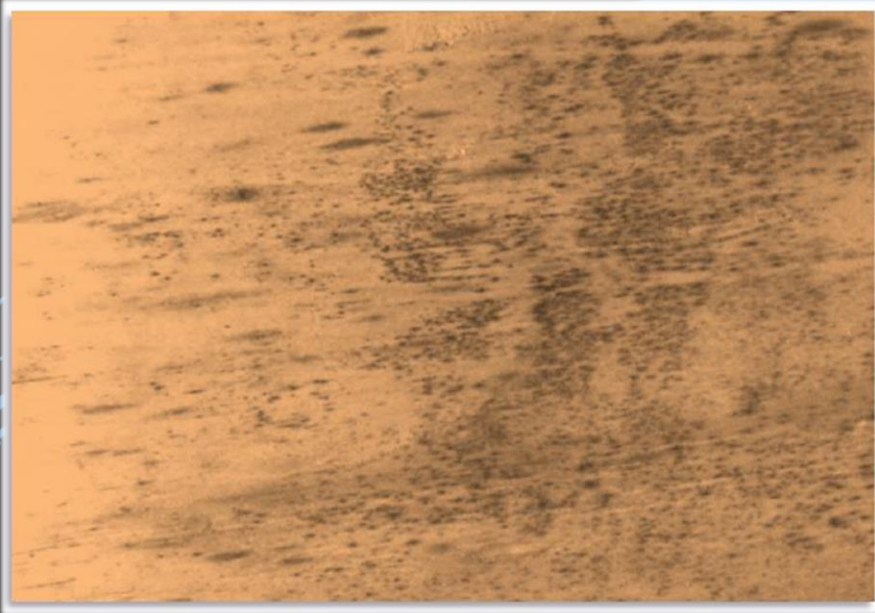
# Under film mould Clear coatings

Slow absorption of moisture can solubilise sugars present with in timber creating a food source for mould spores which are already present.

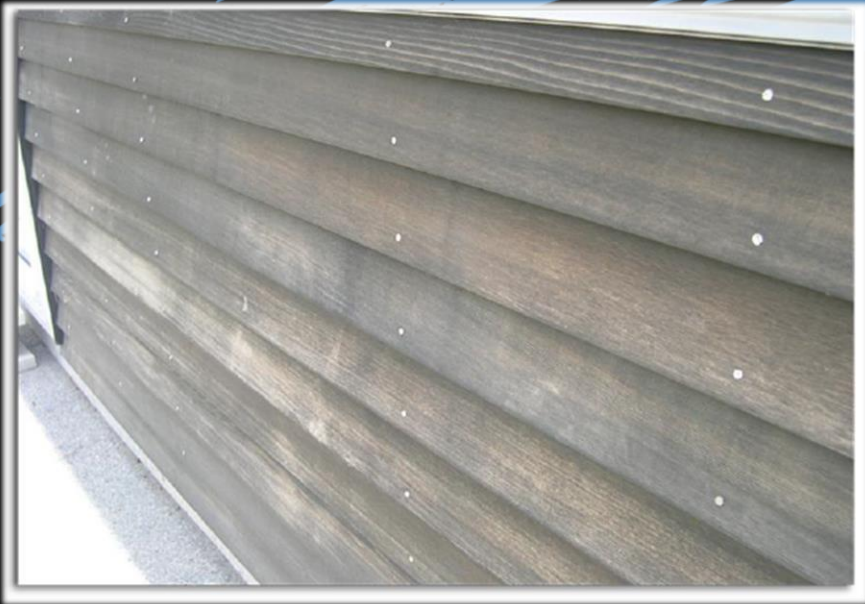
# Weather erosion Exterior stains

This is normal wear & tear as timber stains are designed to erode so as not to build up excess film on timber. North facing will erode much faster the South.

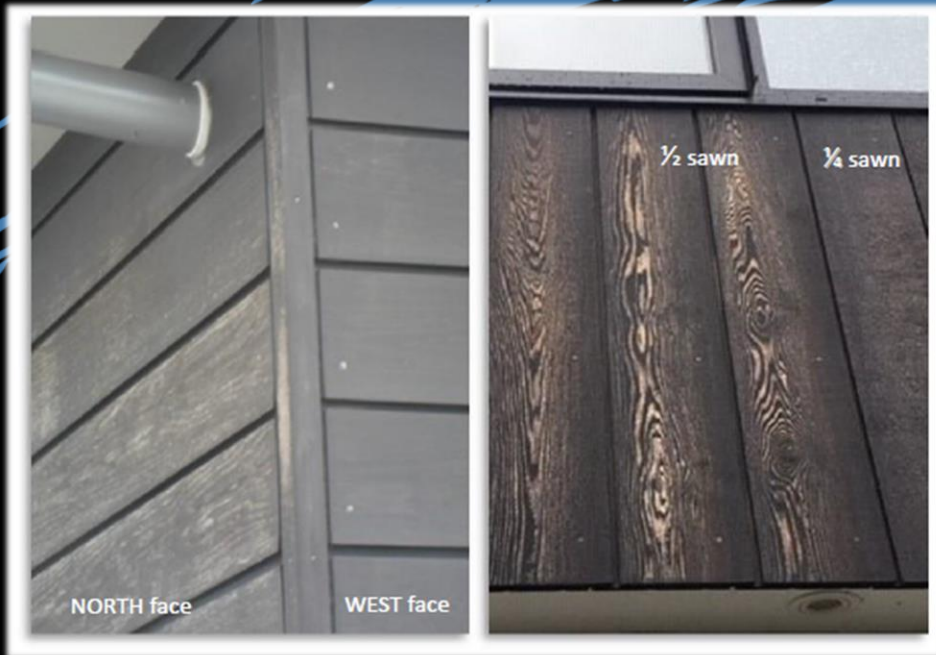
# Weather erosion

This is normal wear & tear as timber stains are designed to erode so as not to build up excess film on timber. Different density of Early vs Late wood grains in the different cuts of timber means different absorption levels of stain and therefore erosion levels.

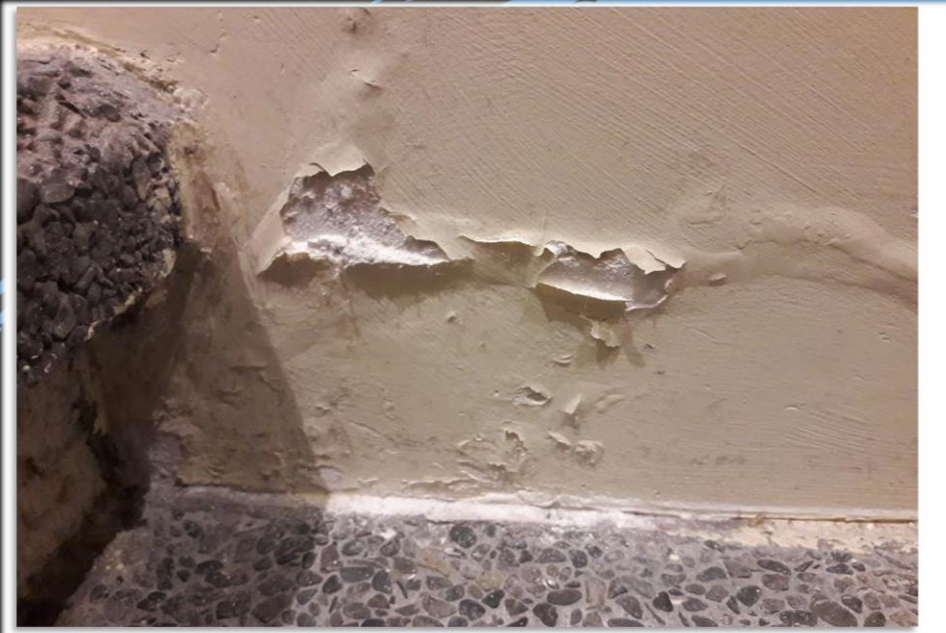
# Efflorescence

Moisture related issue. Moisture carries Calcium Hydroxide (lime) to the surface, reacts with carbon dioxide, forms insoluble calcium carbonate (efflorescence)

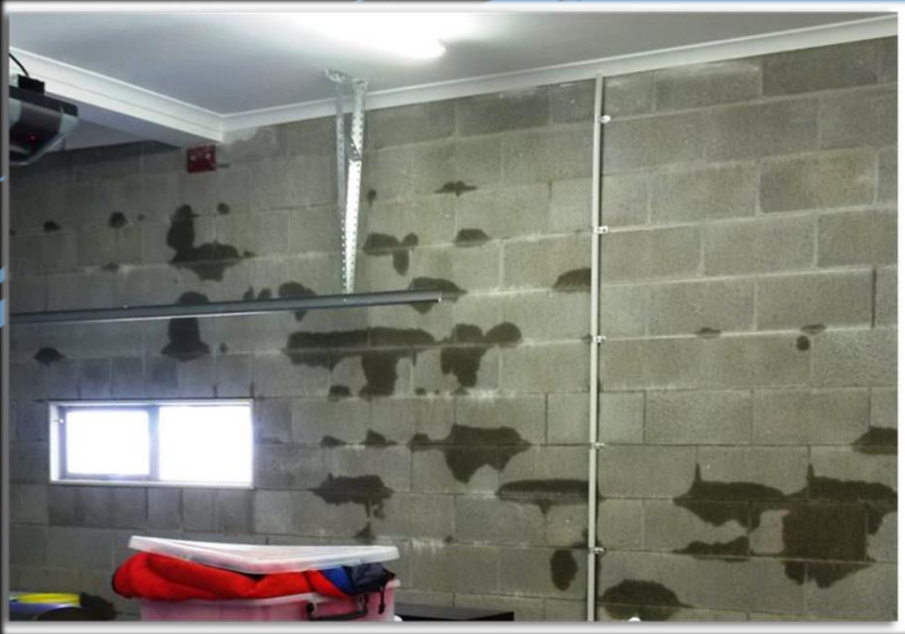
# Water Ingress Porous blocks/ Wind pressure

Exterior of Block not adequately coated to provide a weathertight area. Concealed gutters, roof line, flashing issues etc can also contribute

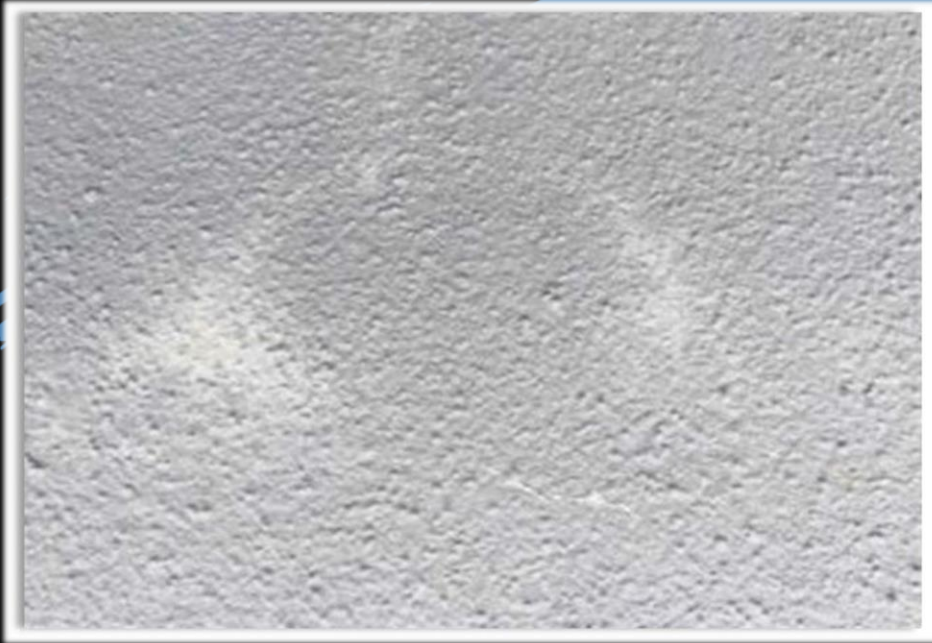
# Lime Burn

Fresh concrete/cement/plaster are initially very alkaline (pH of 13 to 14). Paint applied too soon can result in “burn through” of binders (lime burn).

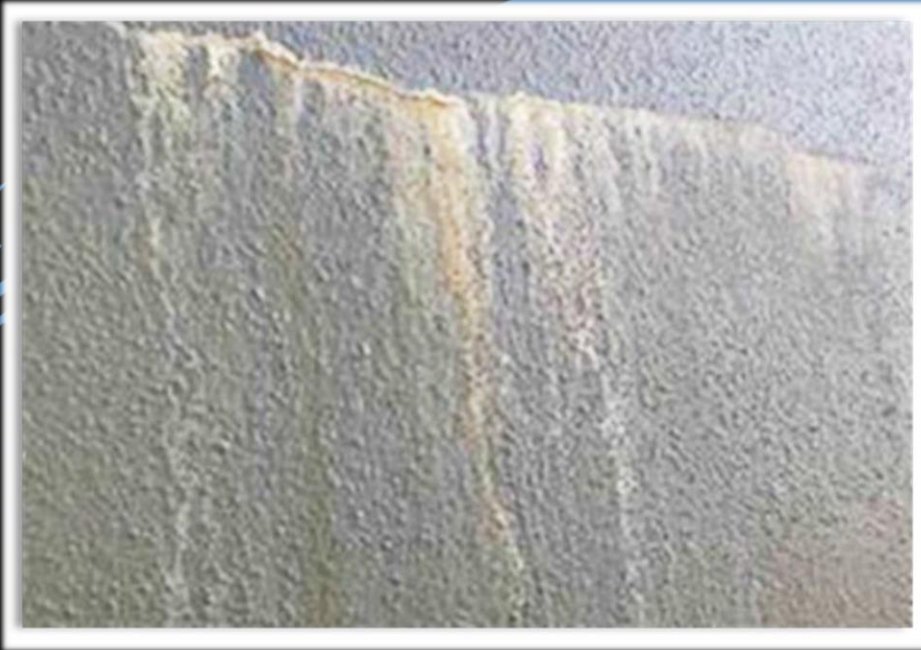
# Lime Staining

Similar to efflorescence Lime staining is caused by moisture. Excess Lime reacts with carbon dioxide to form efflorescence

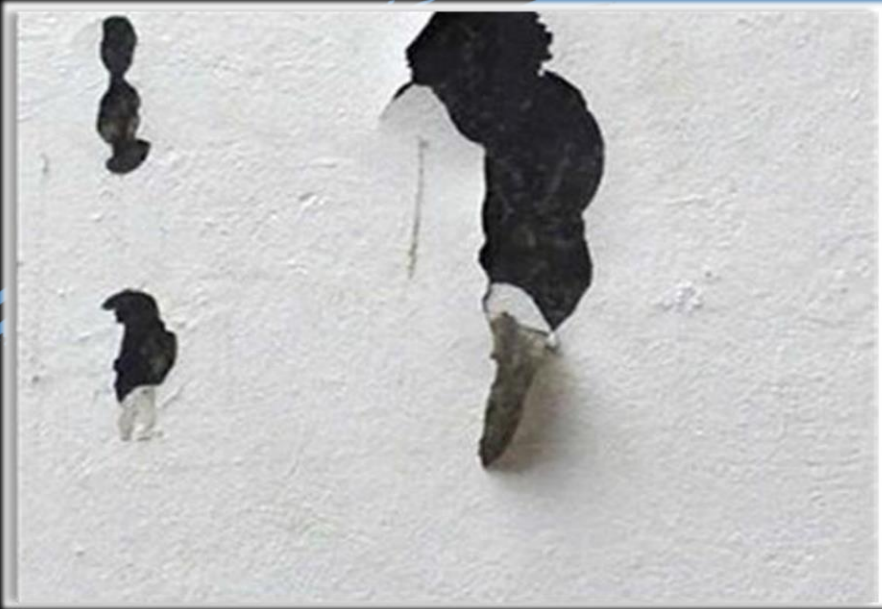
# Old Bitumen coatings

Early waterproofing membrane were 2-5 coats of bitumen emulsion followed by latex coatings. Inter-coat adhesion becomes weak and eventually lets go

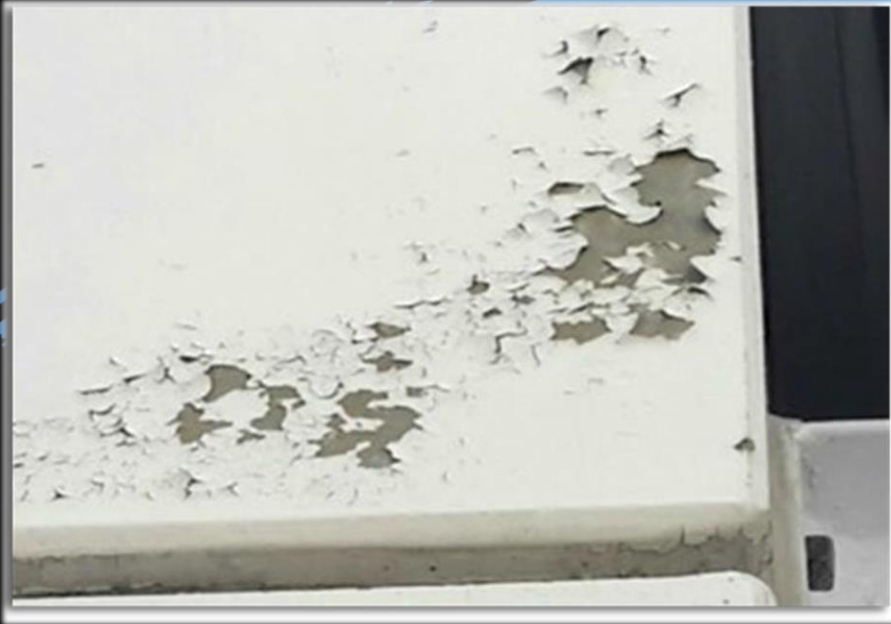
# Precast/Tilt slab

## Probable Cause:

Failure to remove form oils/release agents used in manufacturing process prior to painting. (waterblasting does not adequately remove form oils /release agents). Smooth surface also contributes to the issue.

## Remedy:

Remove all poorly adhering area, scrub down to remove release agents. Prime with suitable primer

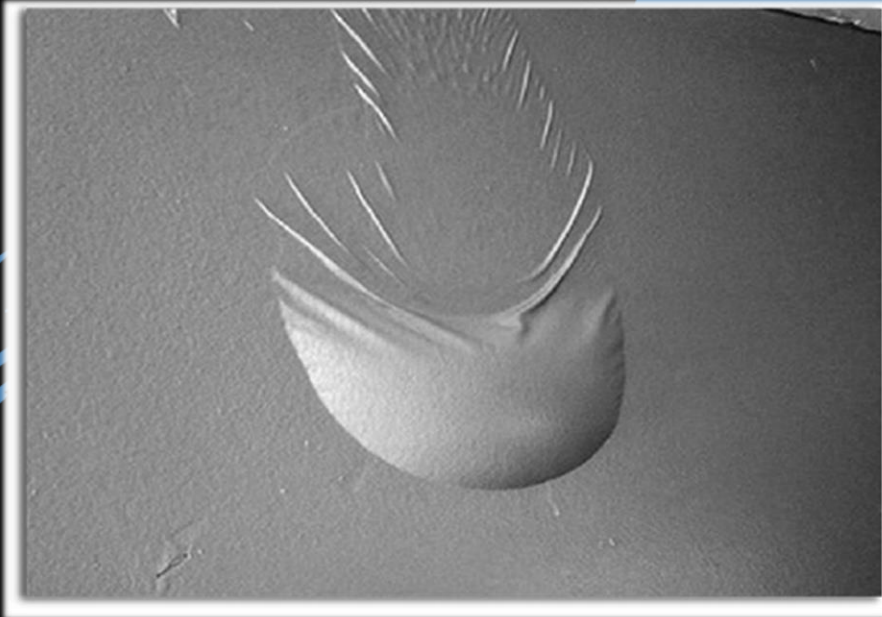
# Water source blisters

## Cause:

Excessive moisture source behind coating or within the substrate

## Remedy:

Find cause of moisture and rectify it

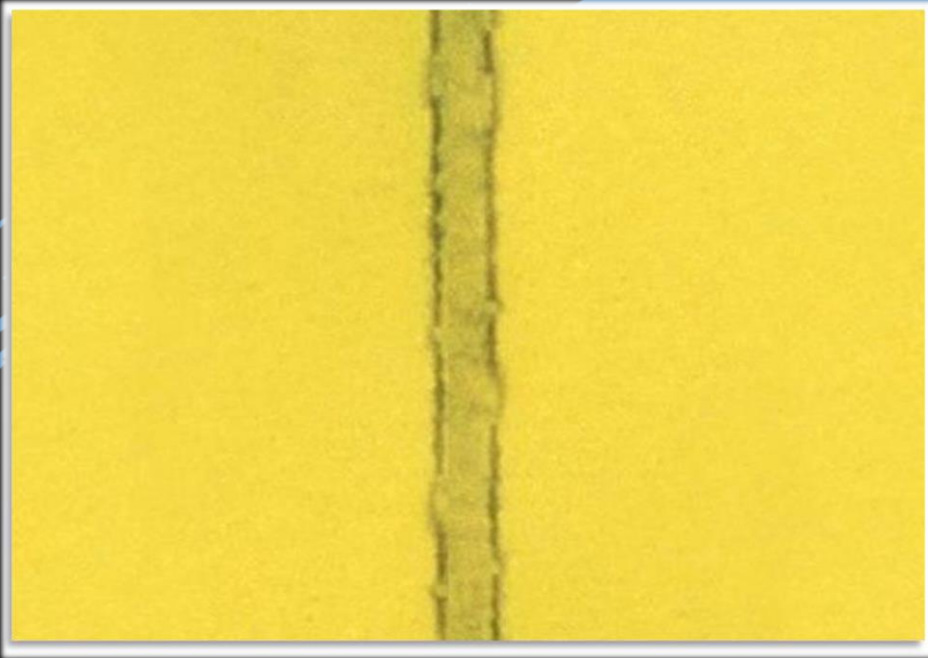
# Painted construction Sealants

## Cause:

Until recently most construction joint sealants were not intended to be painted. Plasticisers in the sealants migrate through the coatings causing it to become tacky and pick up dirt etc easily.

## Remedy:

No remedy. Some who paint them are happy for the discolouration to occur

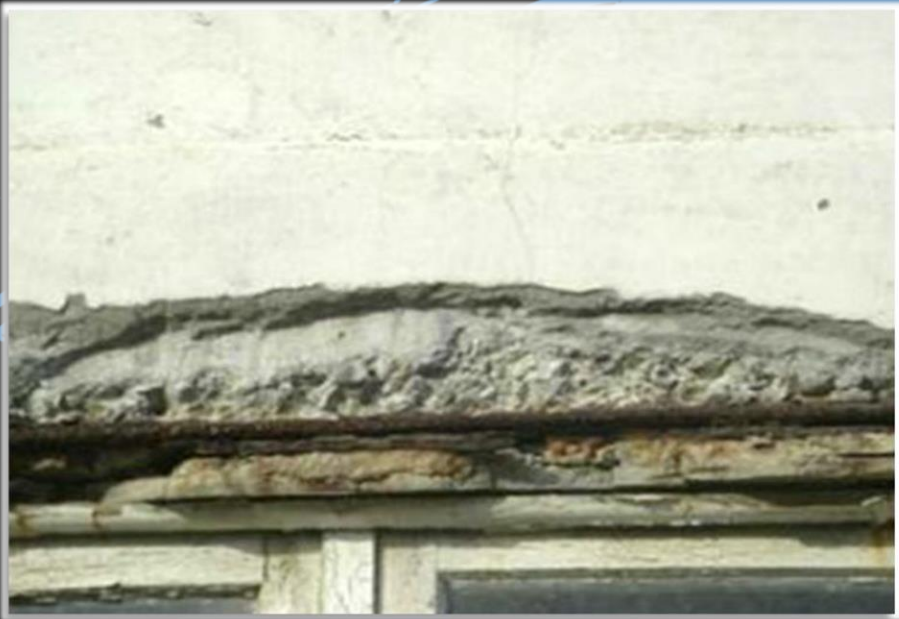
# Concrete Spalling

## Cause:

Often a combination of poor design and insufficient concrete cover, along with weather conditions causes the concrete to erode and crack the concrete. Small cracks become larger

## Remedy:

Specialist Spalling engineers should be engaged

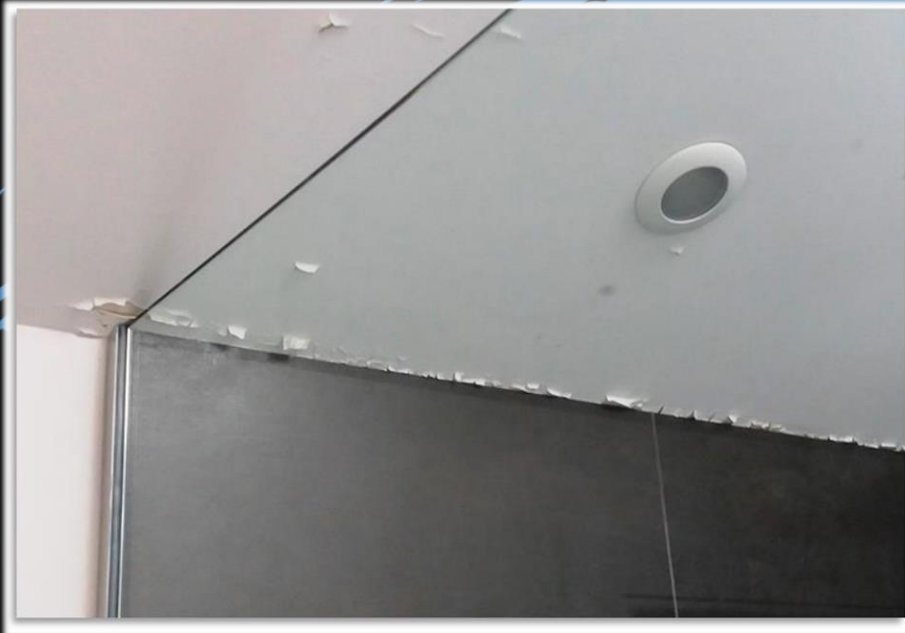
# Adhesion failure Steam & water

## Cause:

Poor surface preparation, incompatible coatings, lack of a good barrier sealer prior to top coats. Moisture penetration in form of steam and surface condensation etc

## Remedy:

Strip to remove loose coatings, clean and seal with suitable barrier sealer base coat before applying topcoats

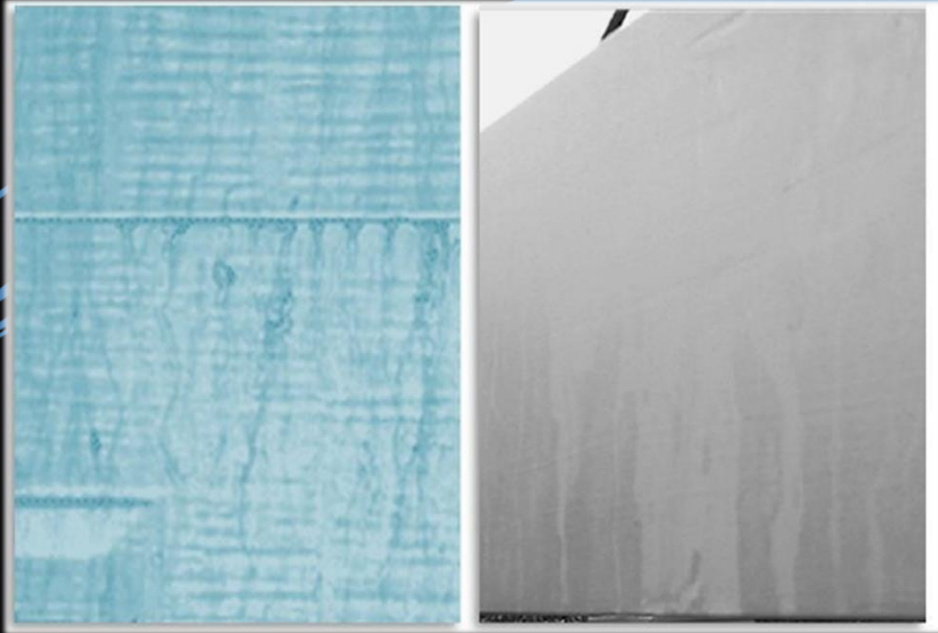
# Surfactant Leaching

## Cause:

Caused by water settling on waterborne coatings too soon after painting. Water softens the fresh paint and draws out water soluble surfactants. As water dries surfactants are deposited on surface

Ensure good airflow & drying conditions. Avoid cool, damp, low air flow conditions if possible.

## Remedy:

Clean down as soon as possible using a mild detergent and warm water

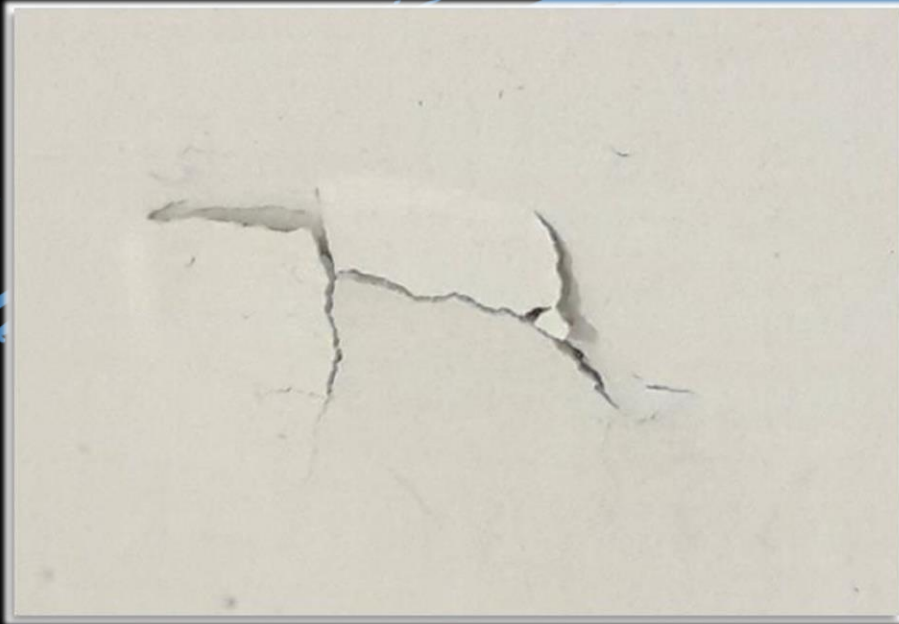
# Stress cracking

## Cause:

Multiple coats of paint applied over weak plaster compound. Surface tension on new paint pulls plaster from the surface

Use correct consistency of plaster compound and allow proper drying conditions prior to painting

## Remedy:

Requires specialist plasterer etc to strip and replaster

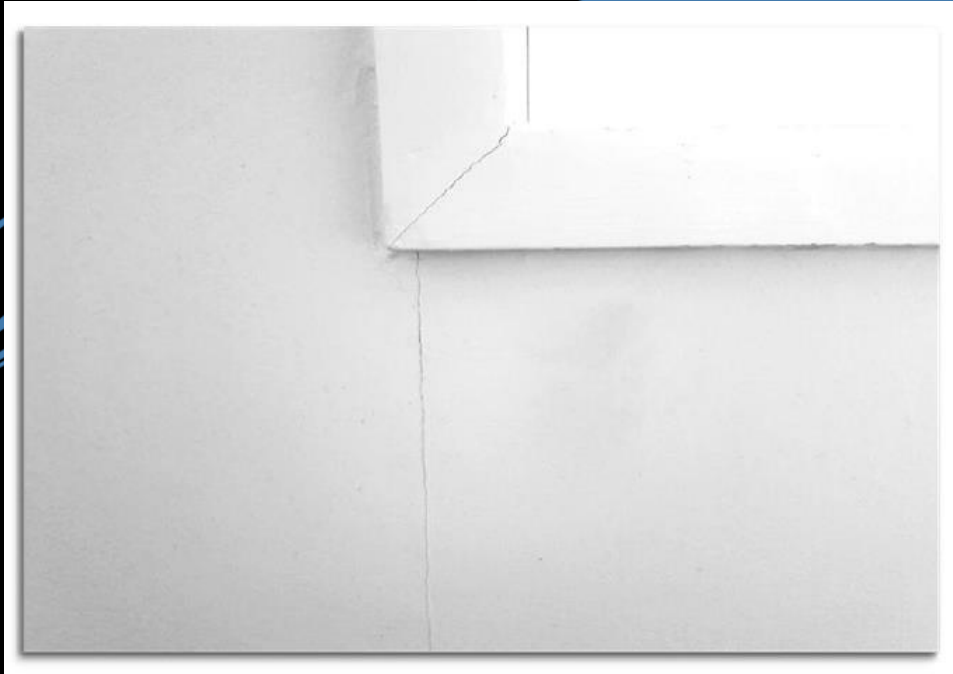
# Stress point & corner cracking

## Cause:

Focus of stresses, building movement, incorrect placement of plasterboard joints

Corner cracking will continue to occur

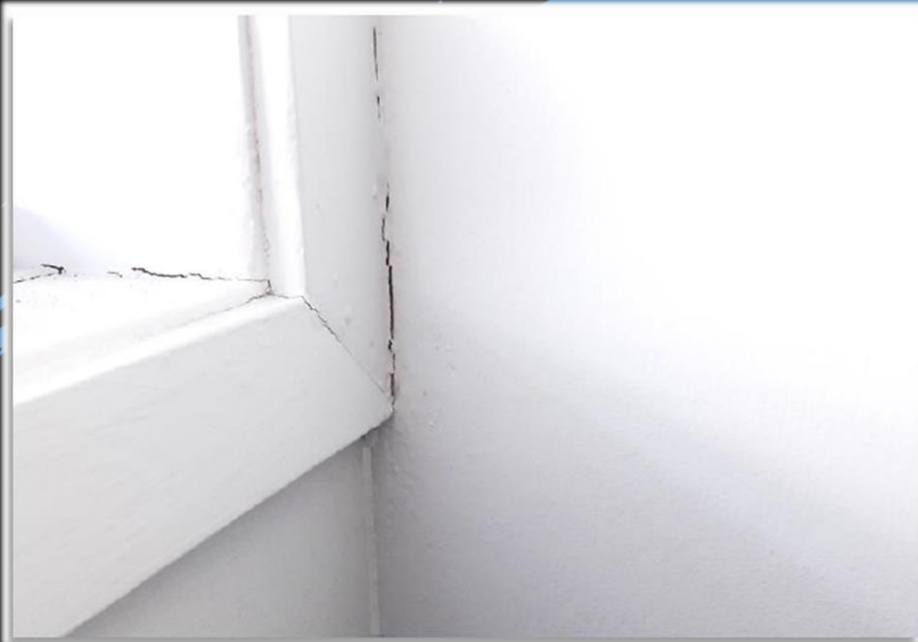
# Bridging

## Cause:

Not using flexible sealant/filler in joints and corners of solid substrates that meet with plasterboard.

Movement causes

## Remedy:

Scrape out , prepare and fill with appropriate filler, repaint

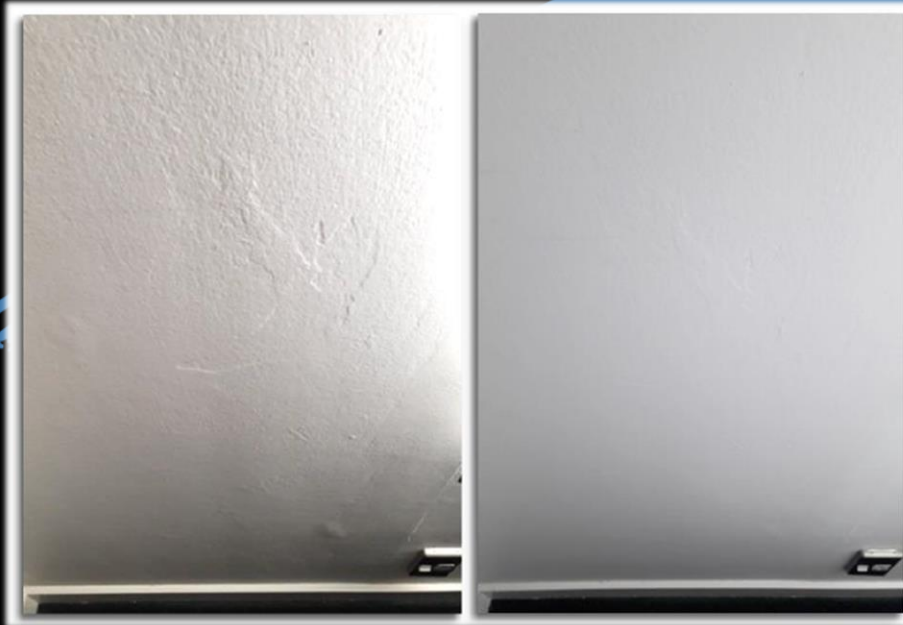
# Critical Lighting

**Cause:**

Critical light source striking wall or ceiling at a shallow angle casting shadows

**Remedy:**

Replastering affected areas

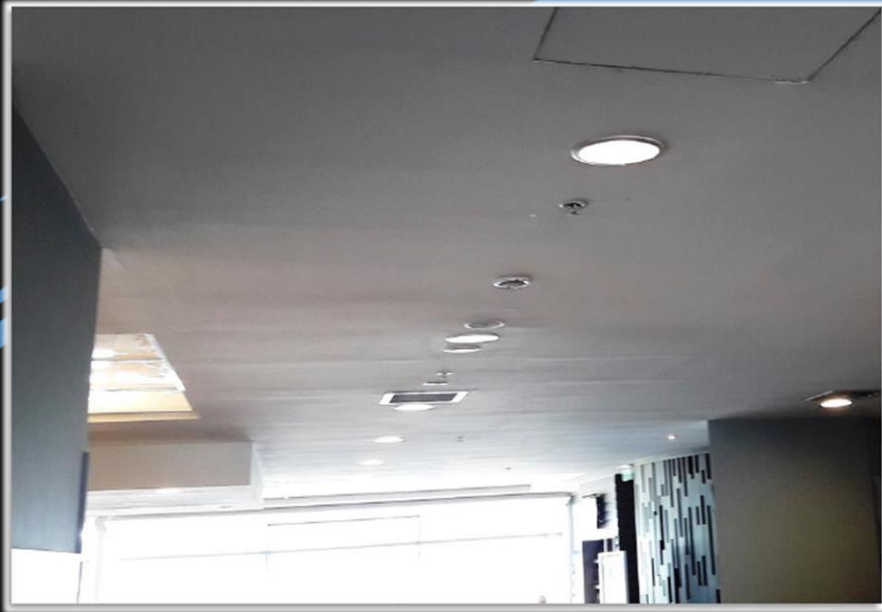
# Wavy surface

## Cause:

Critical light across an area with potential framing issues, fixing issues, moisture or temperature issues in framing or ceiling space etc

Difficult to remedy without significant remedial work

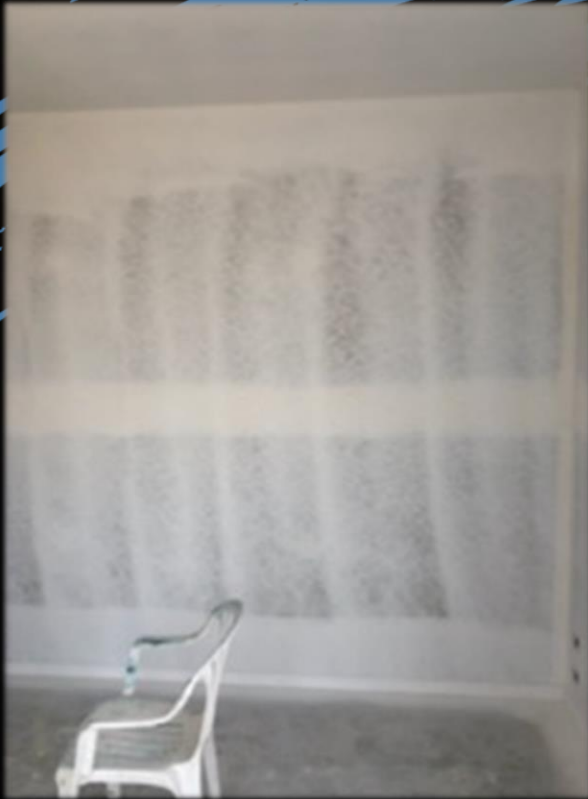
# Coverage

## Cause:

Generally insufficient paint being applied. Often with incorrect application techniques and tools. Incorrect rollers sleeves not applying enough paint

Follow industry standard guidelines along with paint manufacturers recommendations. Apply at correct spreading rates using correct rollers sleeves and tools etc

Apply additional coats to achieve coverage.
