# Common “paint” problems & Paint Guarantees

# Purpose of Common Paint problems & Paint Guarantee

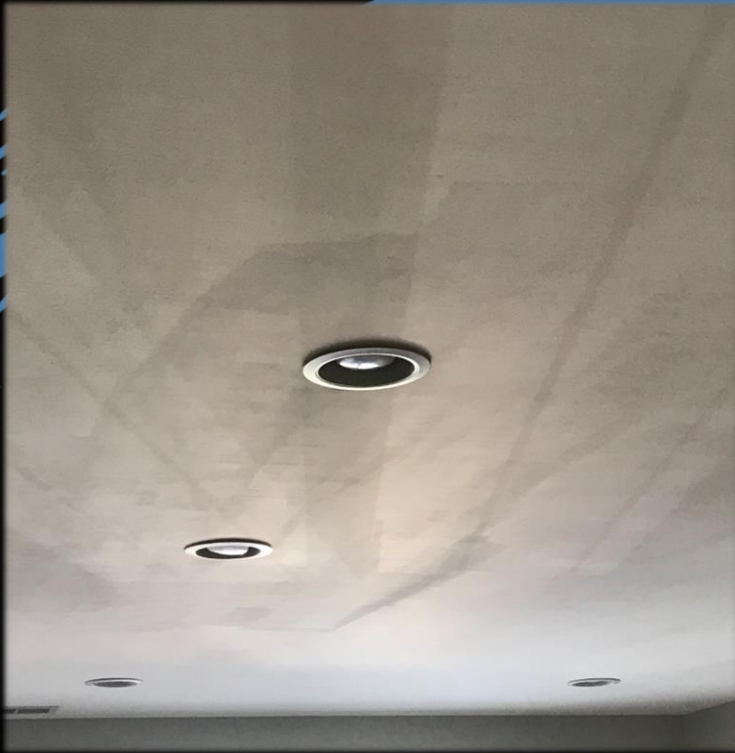
# Roller marks

## **Cause:**

**Coating drying too fast in warm conditions, Poor application technique, over spreading paint applying coating too thin causing fast drying**

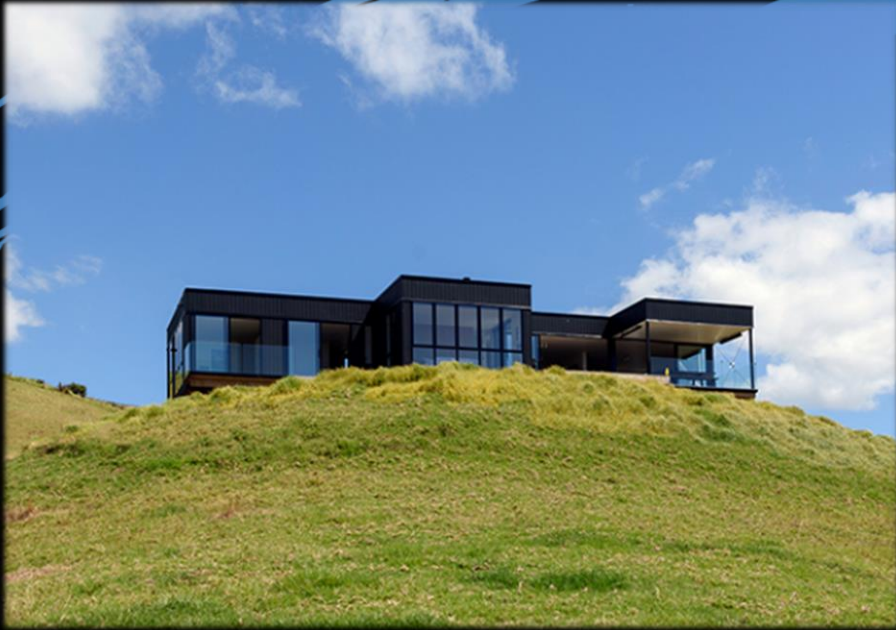
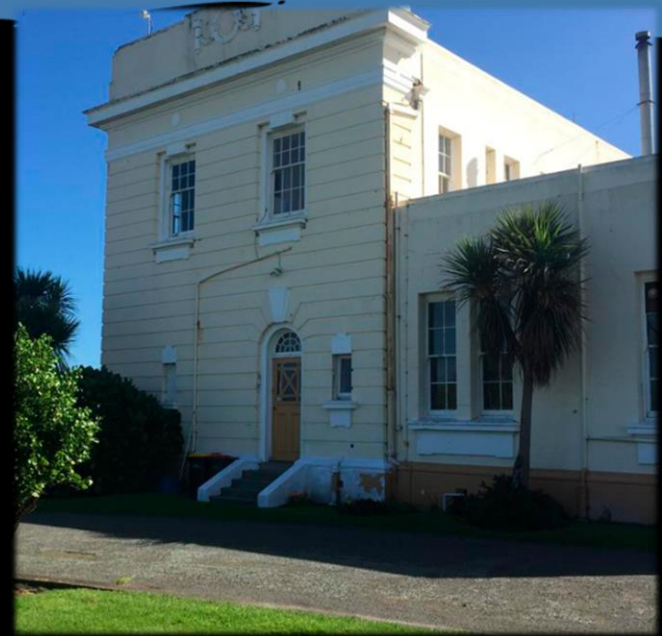
# Substrate & Exposure

Paint coatings on North facing timber will have a far shorter expected life span than paint coatings on South facing concrete. Coatings on substrates that are affected by heat stress will have shorter lifespan than coatings on substrates that aren't

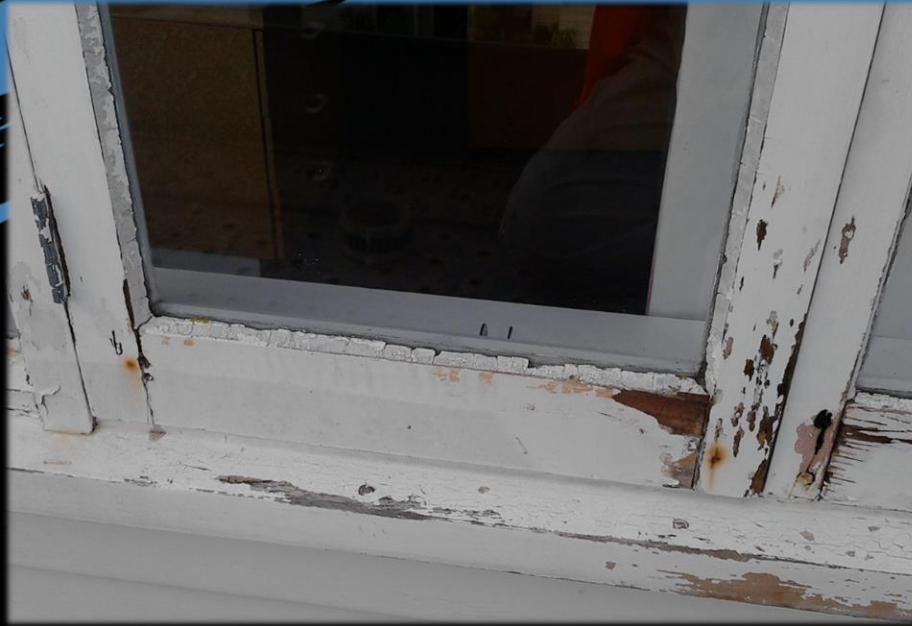
## Substrate & Exposure

**North facing timber joinery, particularly sills, is affected significantly more due to it's angle to the sun which increases UV impact**

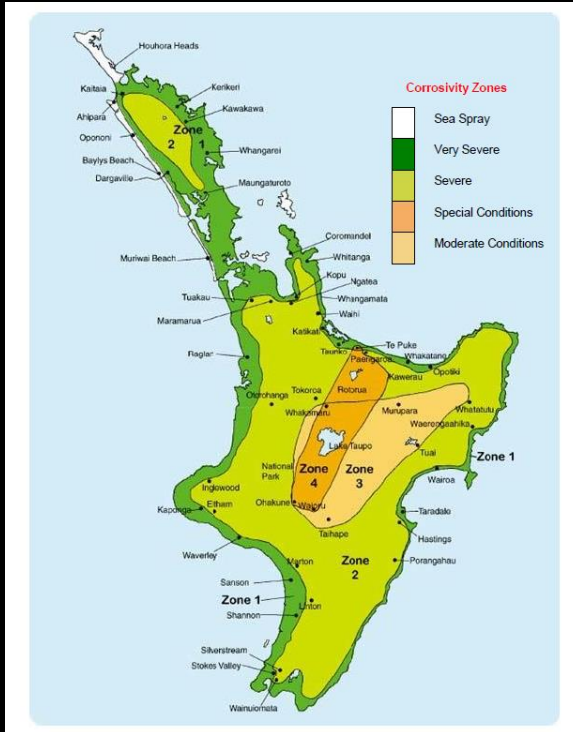
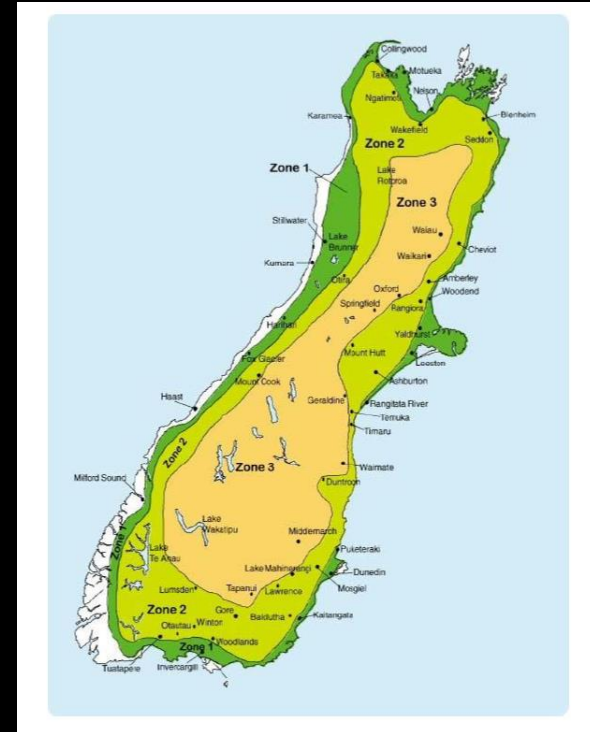
# Environmental Category maps

Description	ISO 9223	Old AS/NZS 2312	Govt Building Code Corrosion ZONES	Typical Exterior Environment
Very low	C1	A	Zone 3	Few alpine areas
Low	C2	B	Zone 3	Arid/rural/urban
Medium	C3	C	Zone 2	Costal
High	C4	D	Zone 1	Sea-shore (calm)
Very High - Industrial	C5-I	E-I	Zone 4	Chemical plants / volcanic
Very High - Marine	C5-M	E-M	Zone 1	Sea-shore (surf)
Sea Shore / Surf extreme	CX	-	Sea Spray	Sea-shore (severe surf)
Inland Tropical	T	F	n/a	Non-costal tropics
